**B\*\*\*\*s \*\*\*\*ig**  
**5\*\*4 H\*\*\*\*\* St**  
**L\*\*\* \*\*\*\*\*R, NY 12\*\*\***  
**HIN™: 12\*\*\*8986**  
**Email: [dr\\*\\*\\*\\*@gmail.com](mailto:dr****@gmail.com)**  
**Inspection Date: 08-04-2020**

**Snyder Home Buyers Inspection Service**  
**Bill Snyder**  
**9 Belvedere Place**  
**Clifton Park, NY 12065**  
**Phone: 5185880784**  
**E-Mail: [bill@snyderhomebuyers.com](mailto:bill@snyderhomebuyers.com)**

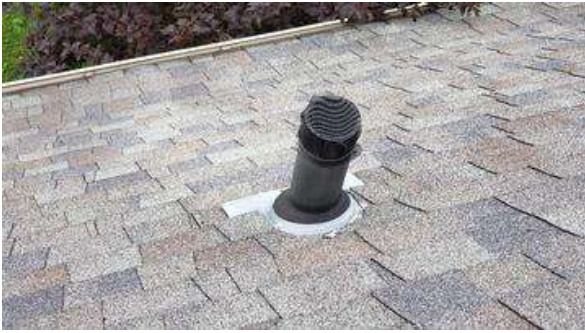
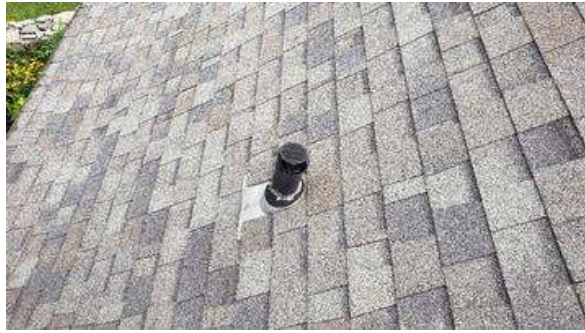
08/31/2020 Vent pipe too low on roof. Snow can accumulate and clog vent pipe causing gas to back up into plumbing system. Recommend qualified contractor repair as necessary.

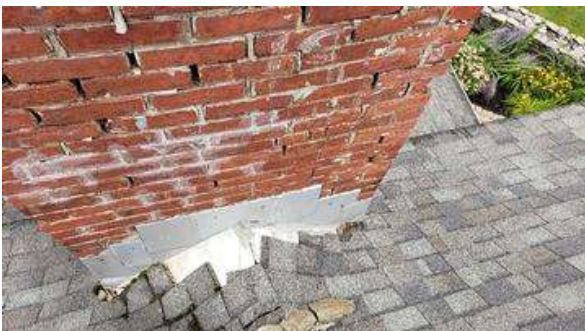
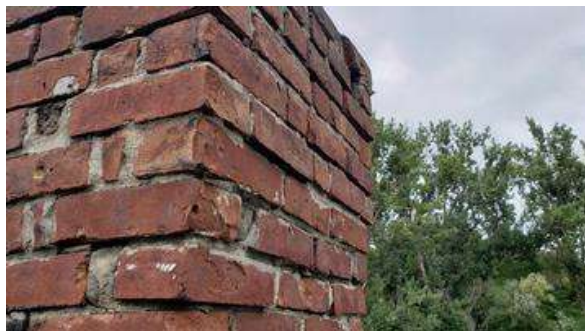
Chimney brick needs re-pointing. Mortar is deteriorated and this will allow for water penetration damage and reduce integrity of the chimney. Recommend qualified contractor repair as necessary.

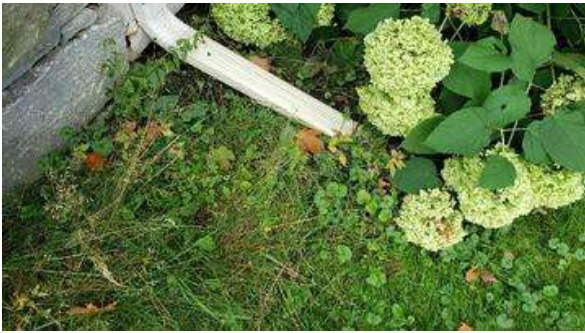
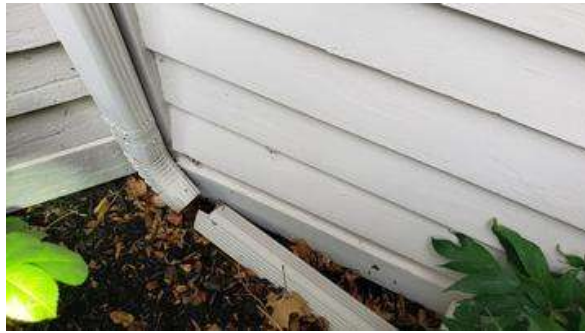
08/30/2020 Gutters had extensions, but they were not long enough to get water away from the foundation. Recommend qualified contractor repair as necessary.

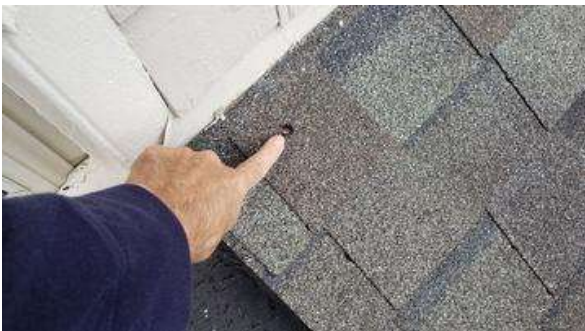
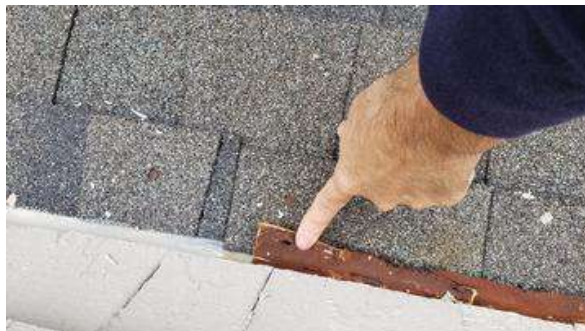
08/31/2020 Nails not sealed with roofing cement. Nails penetrating roofing materials can cause leaks and will allow water to damage wood in attic and sheathing. Nails that are exposed need to be sealed with cement. Recommend qualified contractor repair as necessary.

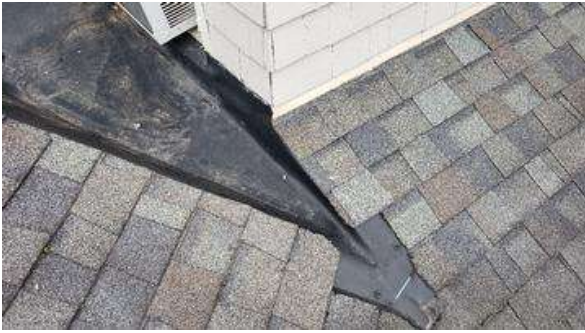
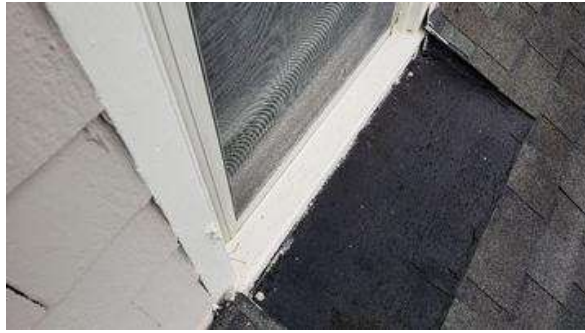
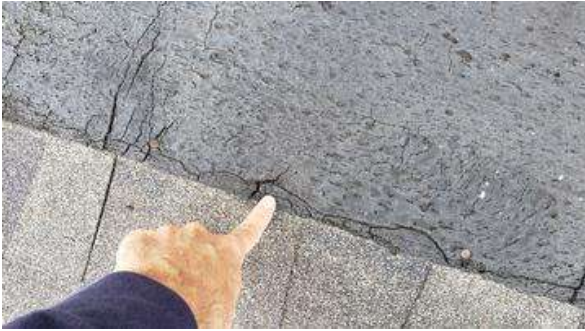
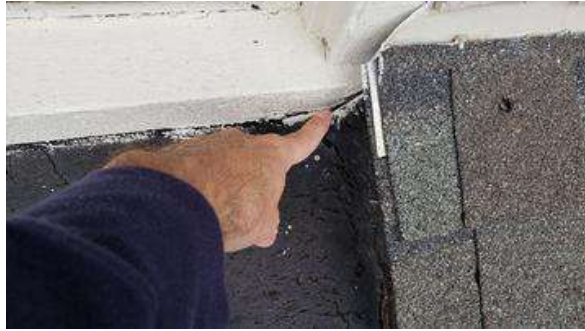
08/31/2020 Flat roof covering not installed properly and will fail causing water damage to wood. Recommend qualified contractor repair as necessary.

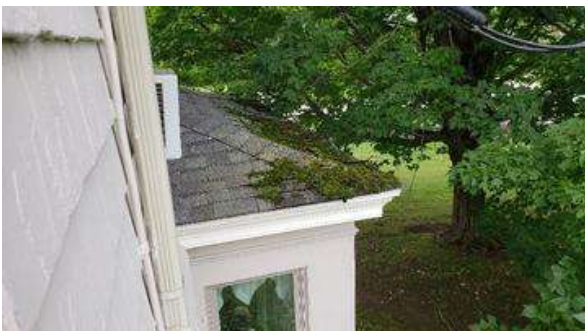
Moss noted on asphalt shingles. This can lead to deterioration of roof decking due to water being leached under the shingles by the moss. Recommend a qualified contractor repair as necessary.

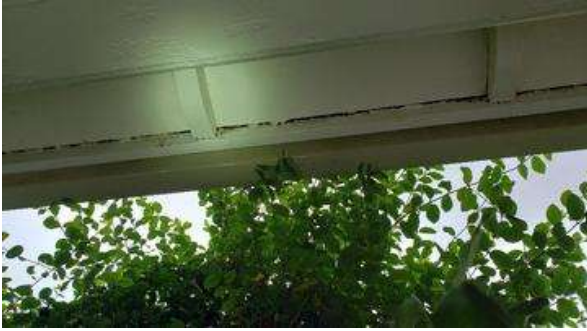
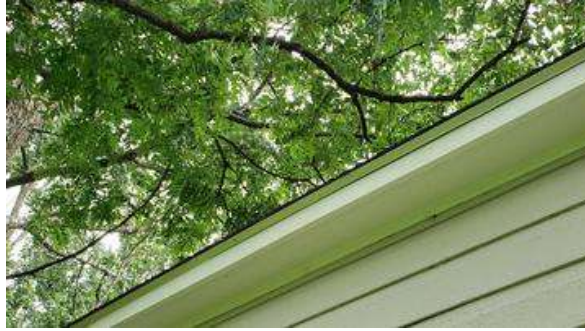
09/01/2020 Trees are overhanging roof and are within 10 feet of roof vertically. Tree debris will hold water on shingles allow it to seep under over time and damage the wood sheathing. Recommend qualified contractor repair as necessary.

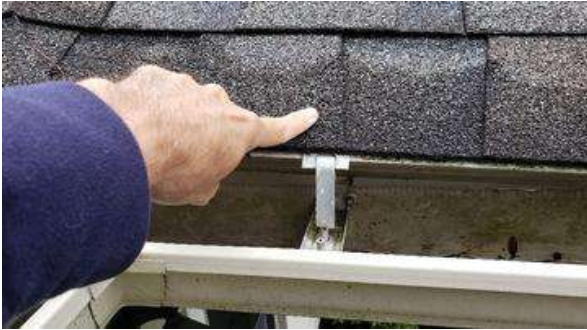
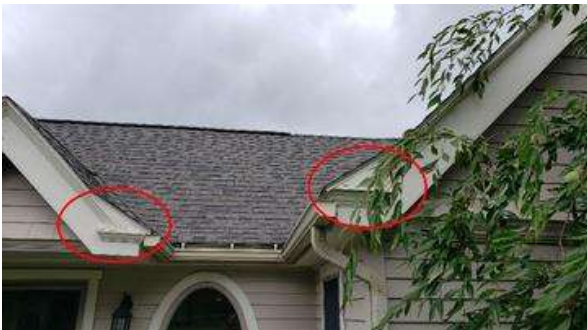
09/01/2020 Rotting wood on fascia boards due to gutter system that was integrated into roof that allowed water to infiltrate under shingle. Recommend qualified contractor repair as necessary.

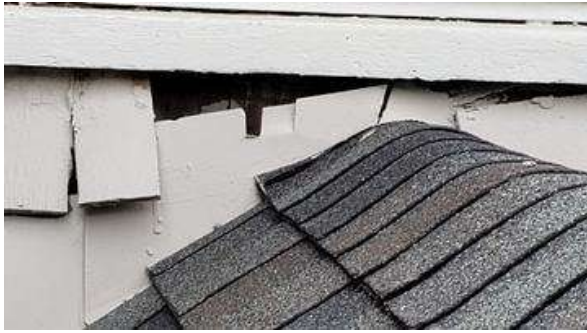
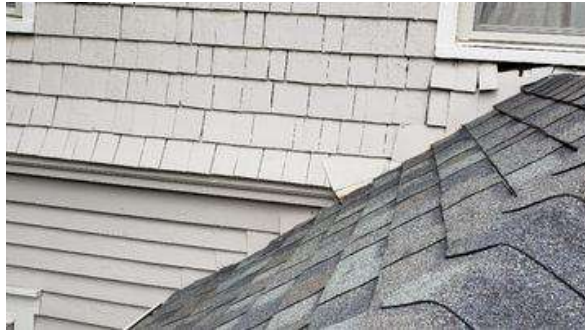
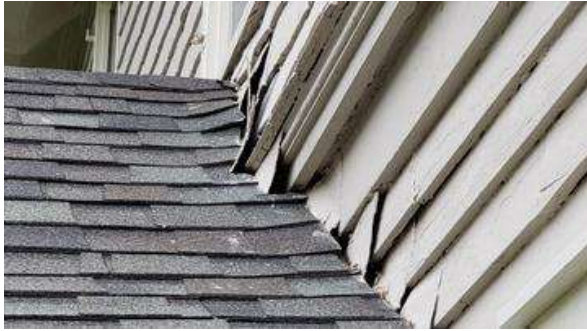
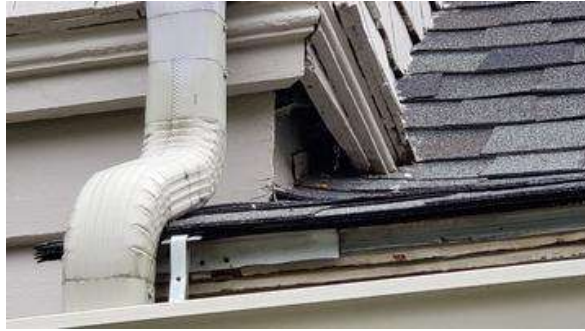
09/01/2020 Transition from siding to shingles not finished properly when installation occurred leaving a gap/hole. This can cause water infiltration and damage/mold to to attic and interior. Recommend qualified contractor repair as necessary.

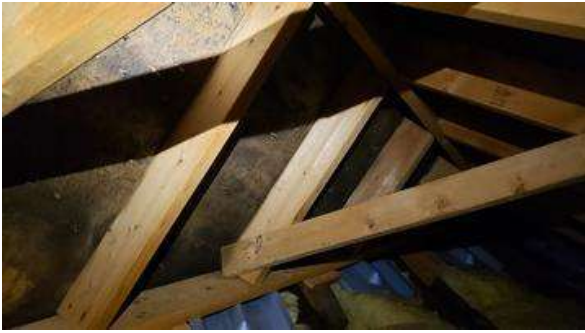
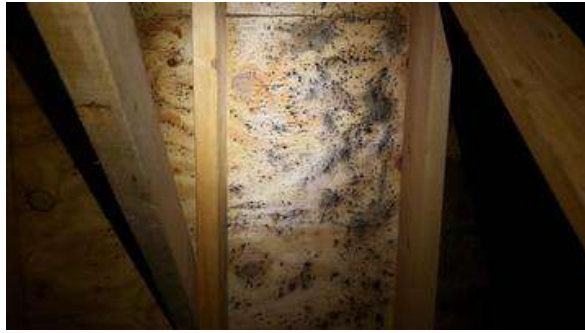
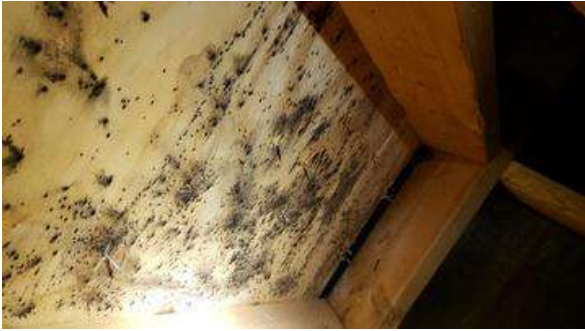
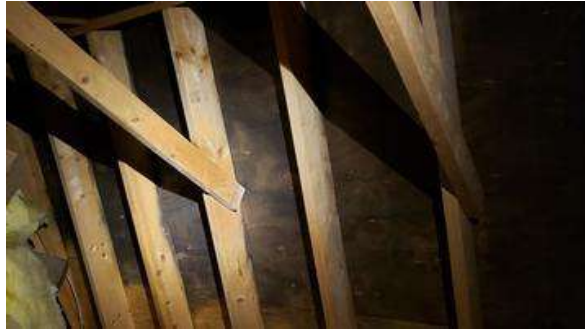
09/01/2020     \$1500 REPAIR OR MORE: Mold noted in attic. Recommend contacting a New York State licensed mold assessor to have assessment performed for remediation.

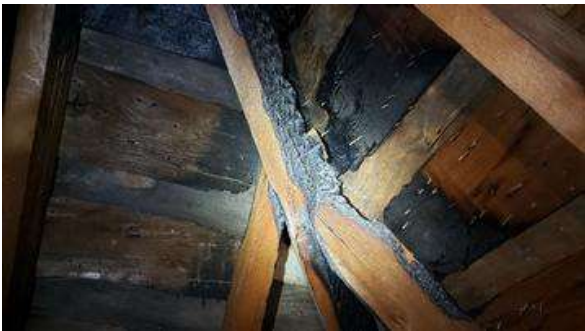
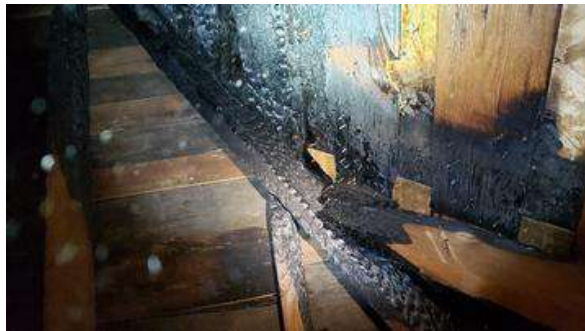
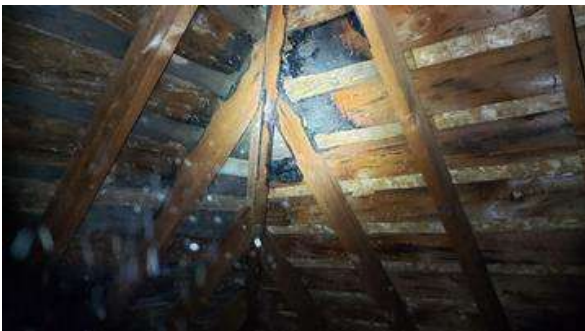
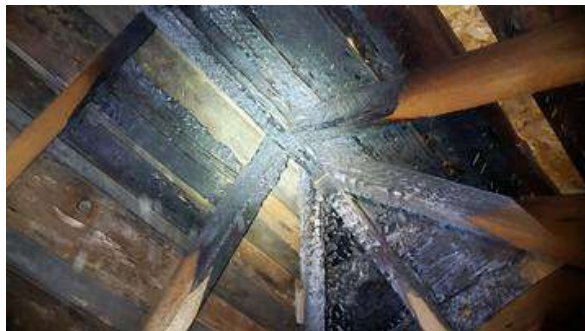
\$1500 REPAIR OR MORE: Fire damage in attic leaving structure integrity to be questioned after rebuild. Recommend qualified contractor repair as necessary.

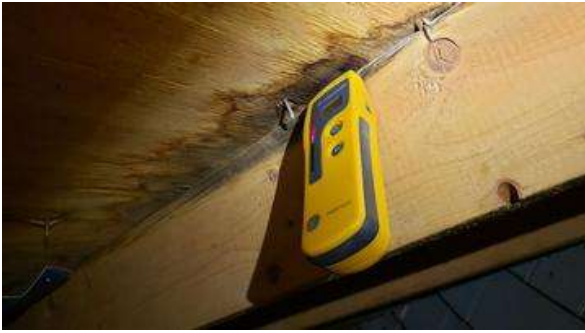
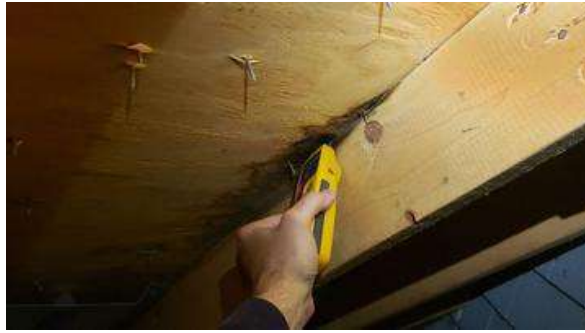
Active leak noted coming from roof decking. This leak will cause damage to insulation and also be a possible source for mold growth. Recommend qualified contractor repair as necessary.

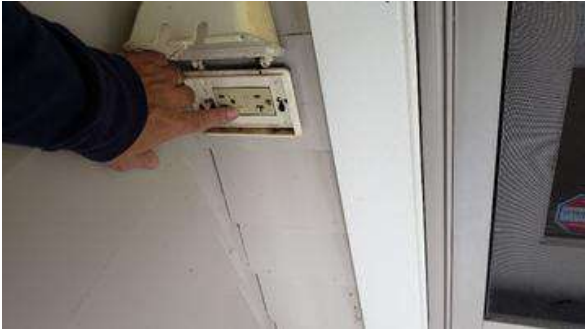
09/01/2020 When tested Ground Fault Circuit Interrupter (GFCI) outlet not "tripping" off with hand held tester. This is a safety issue. Recommend qualified contractor repair as necessary.

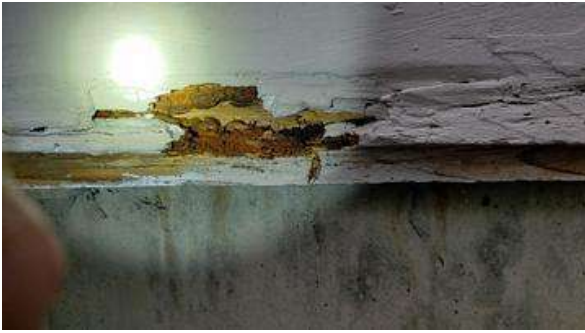
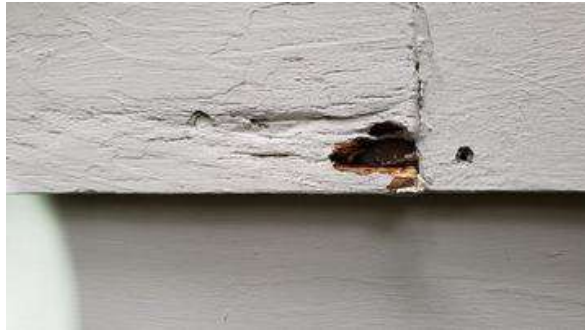
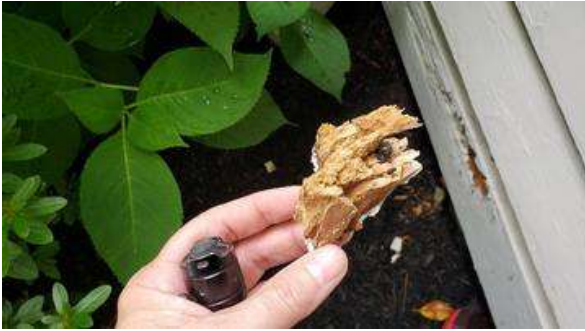
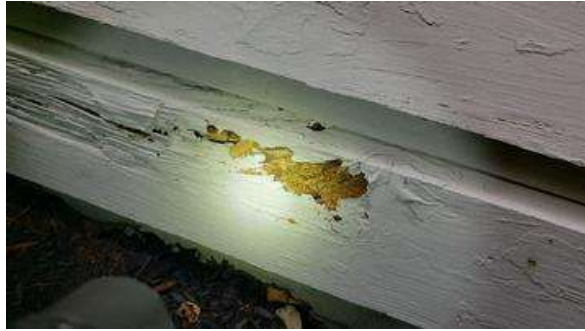
09/01/2020 Wood trim shows signs of deterioration and rot at many places on the siding and posts. Moisture meter shows high levels of water and rotting wood under the paint. Recommend qualified contractor repair as necessary.

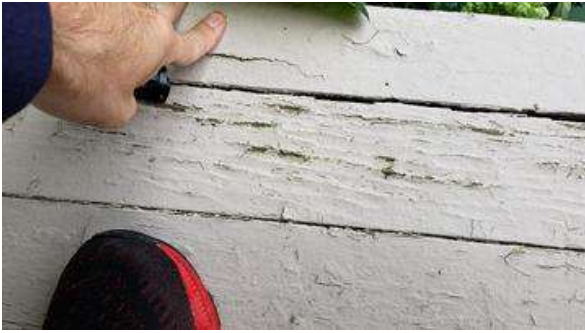
End board of deck is rotted and broken. This is a safety hazard when stepping on and off of deck. Recommend qualified contractor fix and repair as necessary.

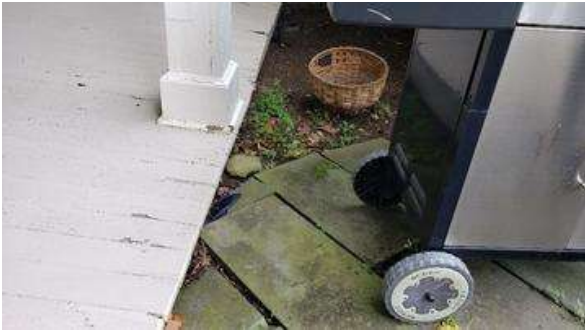
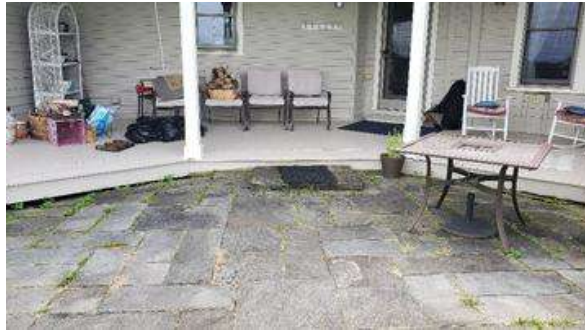
08/30/2020 Back patio paving stones are uneven and slopes toward house. This can cause water to accumulate at foundation and cause damage. Recommend a qualified contractor repair as necessary.

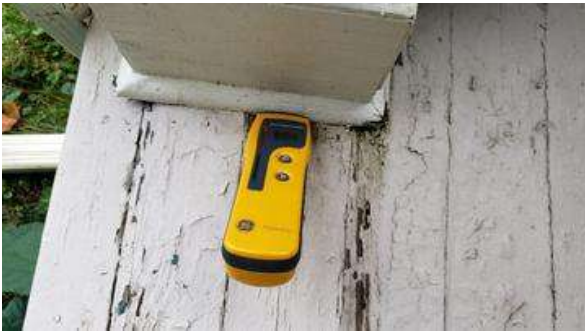
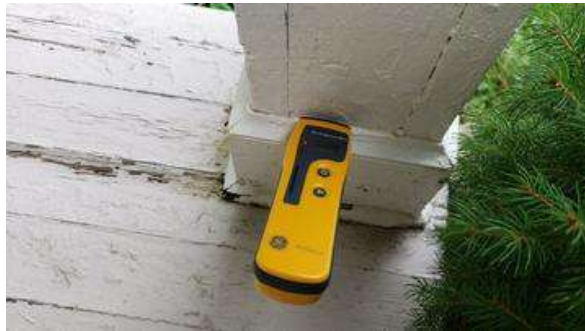
08/30/2020 Posts show high reading with moisture meter at bottom and in contact with deck. Recommend qualified contractor repair as necessary.

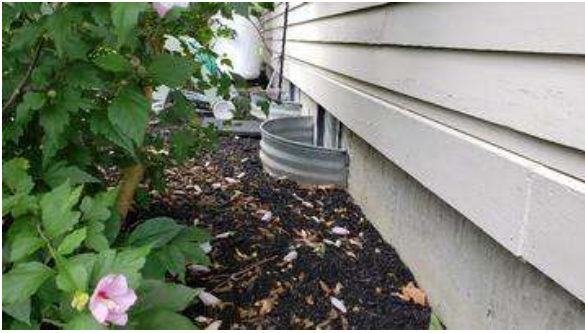
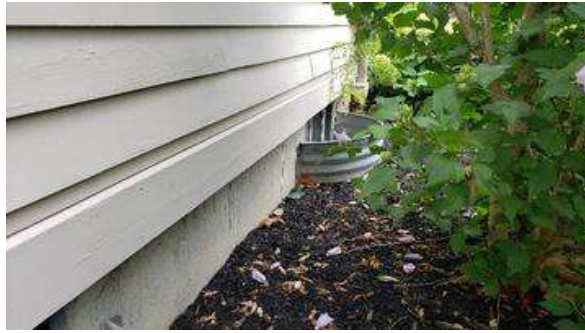
09/01/2020 Perimeter grading slopes towards building. This can cause deterioration to foundation. Recommend qualified contractor to fix and repair as necessary.

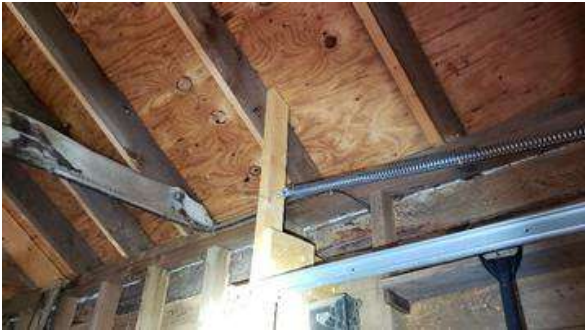
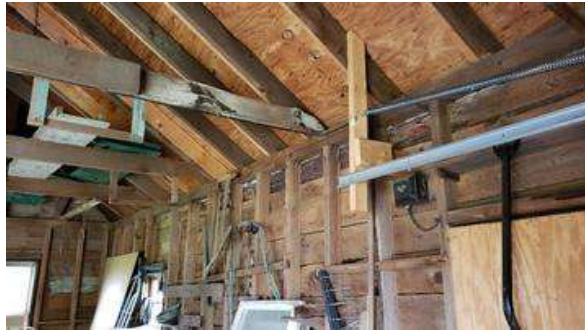
Garage door support brackets are too weakly attached to the ceiling. Support brackets hold door rails and allow for door to move easily into open and close positions. Recommend qualified contractor repair as necessary.

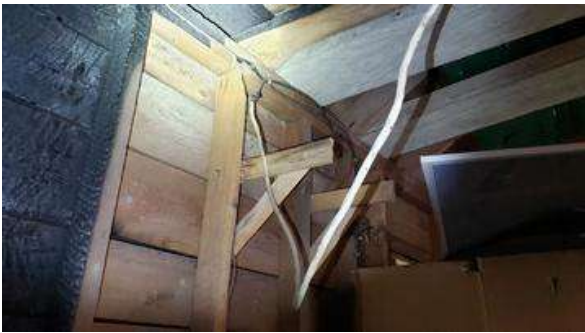
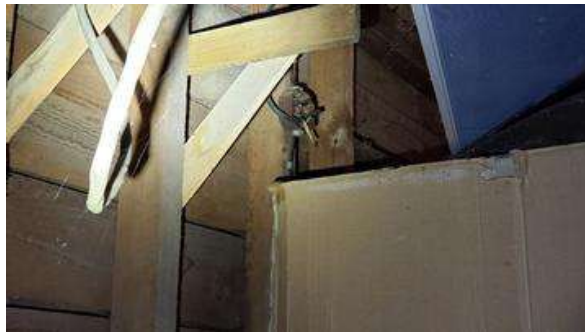
Electrical junction box covers missing and live wires exposed in numerous places. Covers keep live wires and connections from being shorted or being touched by accident which could lead to shock or fire. Recommend qualified contractor repair as necessary.

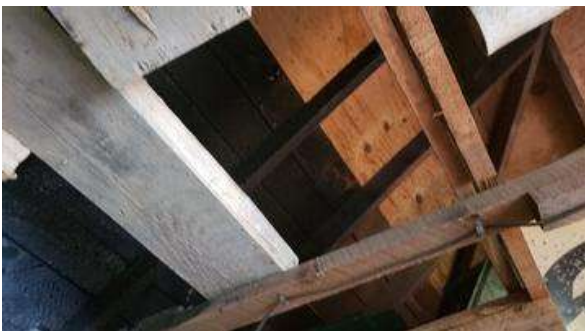
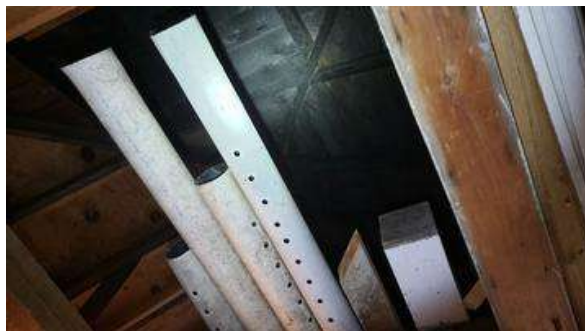
Fire damage in attic leaving structure integrity to be questioned. Recommend qualified contractor repair as necessary.

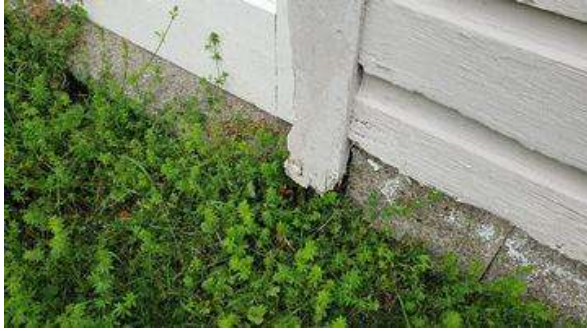
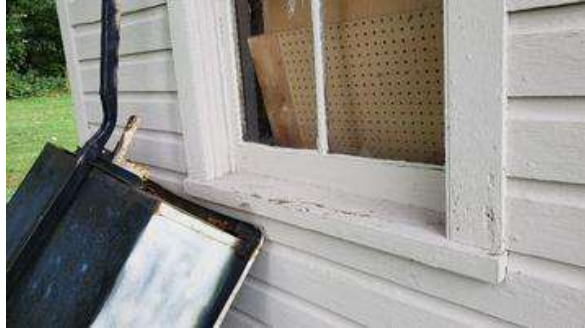
09/01/2020 Garage siding/trim water damage and rotting due to being in contact with soil. Recommend installing gutter and repairing any rotten areas of structure. Foundation must be kept dry.

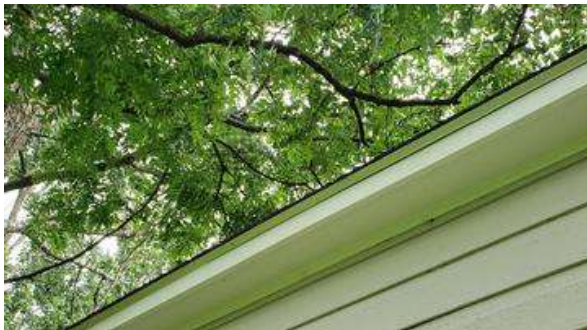
09/01/2020 Trees are overhanging roof and are within 10 feet of roof vertically. Recommend pruning trees so they're at least 10 feet above roof, or don't overhang the roof

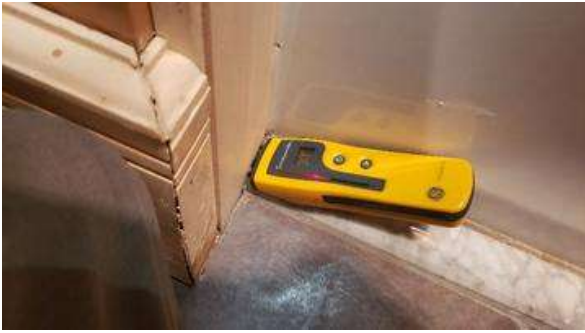
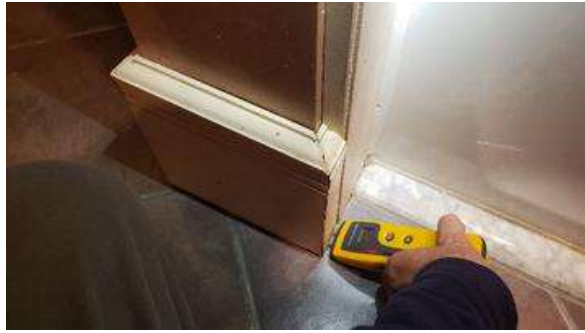
09/01/2020 Moisture meter has detected water penetration in framing behind the tile that will damage wood. Recommend qualified contractor repair as necessary.

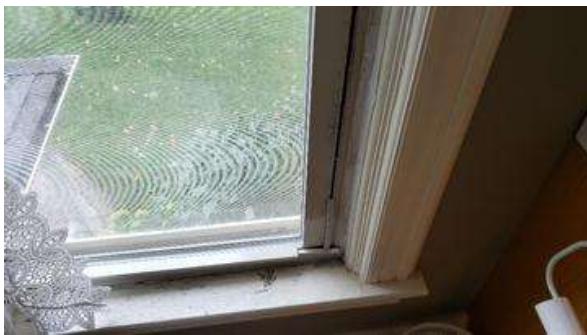
09/01/2020 Windows have gaps on the sides of the frames and can be pushed out as a result of the frame not being shimmed properly. Recommend qualified contractor repair as necessary.

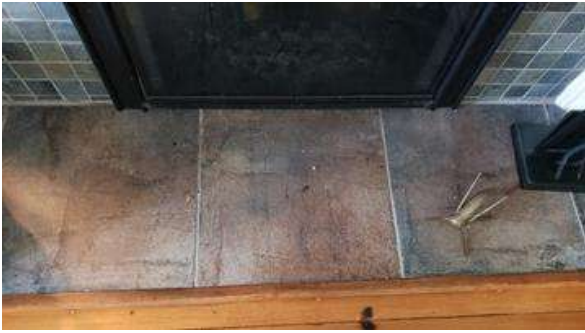
09/01/2020 Fireplace hearth is less than 18" deep. This is a fire hazard. Recommend installing a hearth pad or extending hearth to at least 18" deep.

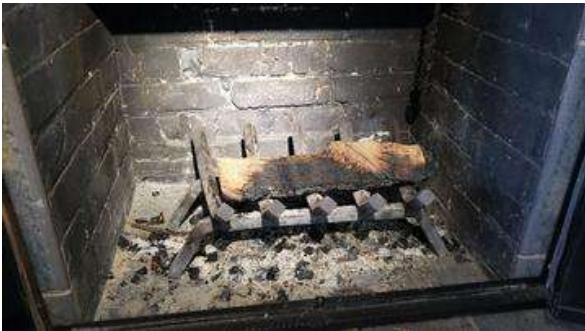
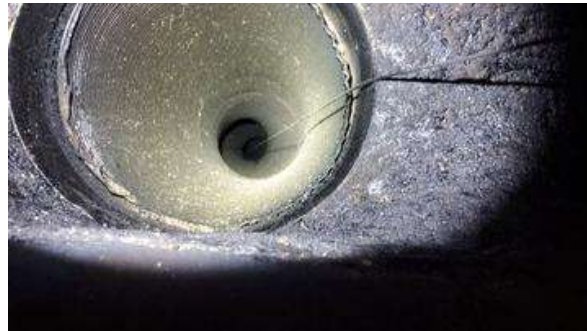
09/01/2020 Recommend a level 2 inspection performed by a qualified chimney sweep. This inspection will determine the condition of the flue liner.

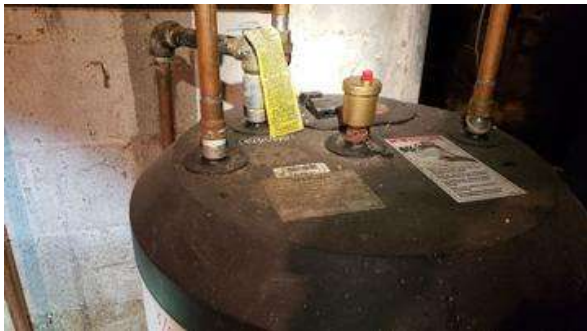
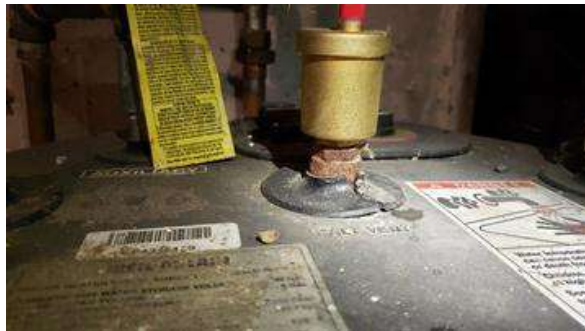
Rusting connections to the tank on top. Hot water heaters are under pressure and rust is a weakening of the tank's ability to contain the pressure. Recommend qualified contractor repair as necessary.

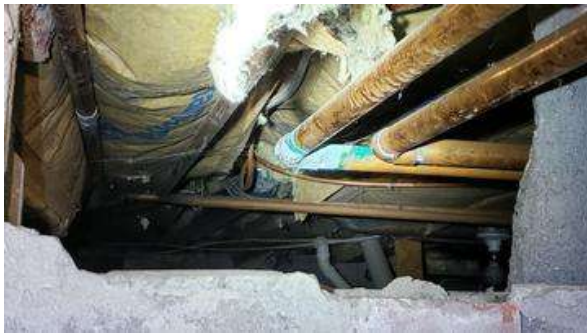
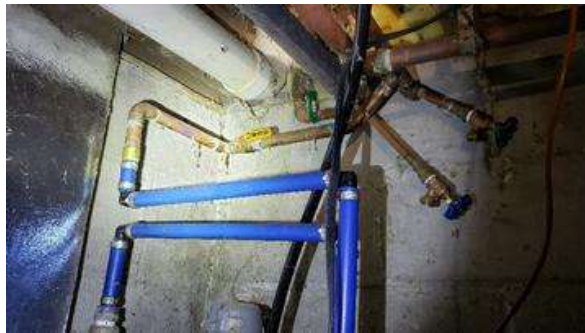
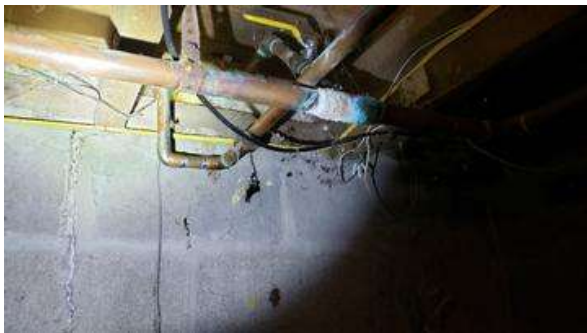
09/01/2020 One or more active leaks were found in supply pipes or fittings. Recommend qualified contractor repair as necessary.

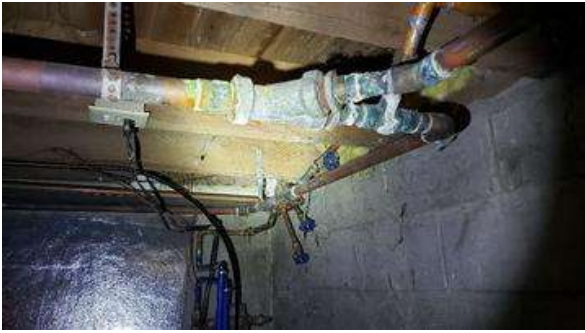
09/01/2020 Some of the heating radiator pipes in the plumbing was galvanized. These are older and will plug up due to interior corrosion. At this time they are functioning as designed.

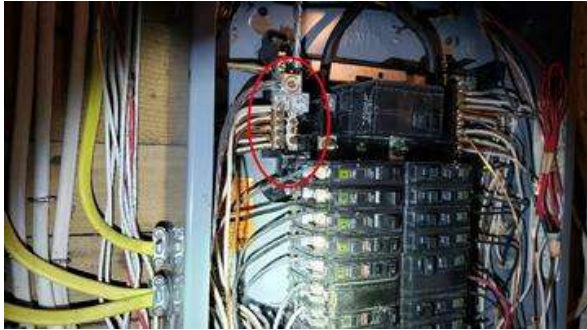
Rust noted in electric service panel. Water may have leaked or be leaking causing rust and is a safety hazard due to shock and fire possibility. Recommend a licensed electrician repair as necessary.

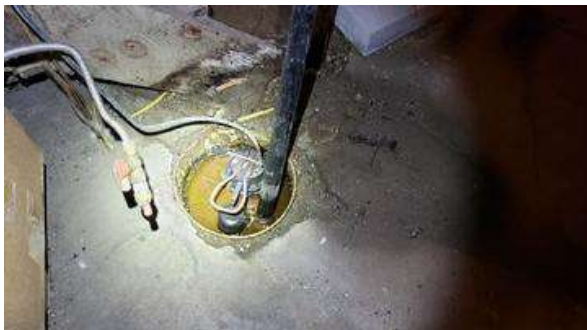
Sump opening not covered allowing for a trip hazard for all and a drowning hazard for small children. Recommend proper covering and blocking access from children.

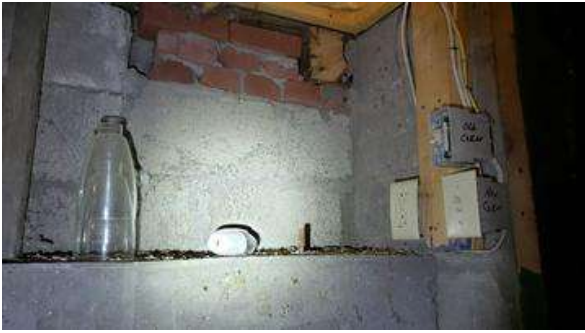
Outlet cover missing. Cover keep live wires and connections from being shorted or being touched by accident which could lead to shock or fire. Recommend qualified contractor repair as necessary.

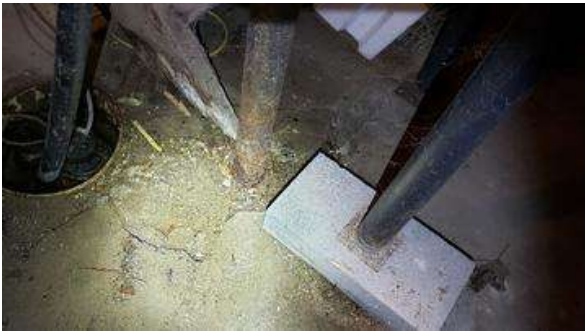
Basement support posts are not properly installed into basement floor. There are no footers to support the posts and the posts are temporary. The floor will crack and posts will sink without footers. Recommend qualified contractor repair as necessary.

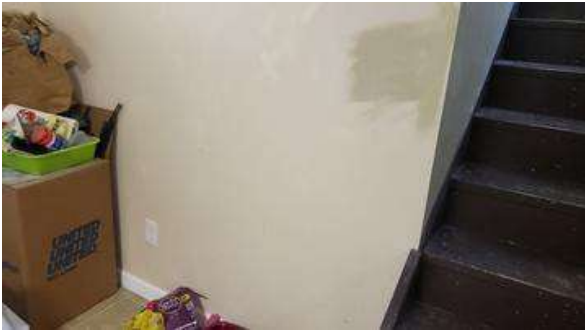
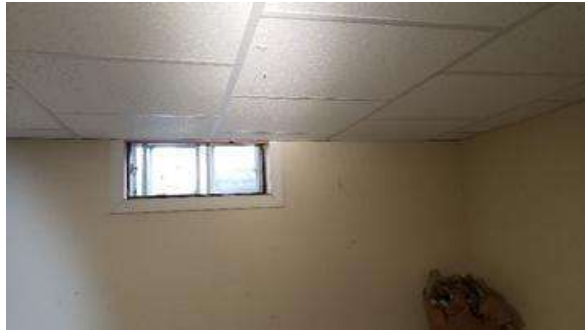
Most of new addition part of basement was finished and many components not visible for inspection. Recommend monitoring over time for water penetration at high risk areas.
