**B\*\*\*\*s \*\*\*\*ig**  
**5\*\*4 H\*\*\*\*\* St**  
**L\*\*\* \*\*\*\*\*R, NY 12\*\*\***  
**HIN™: 12\*\*\*8986**  
**Email: [dr\\*\\*\\*\\*@gmail.com](mailto:dr****@gmail.com)**  
**Inspection Date: 08-04-2020**

**Snyder Home Buyers Inspection Service**  
**Bill Snyder**  
**9 Belvedere Place**  
**Clifton Park, NY 12065**  
**Phone: 5185880784**  
**E-Mail: [bill@snyderhomebuyers.com](mailto:bill@snyderhomebuyers.com)**

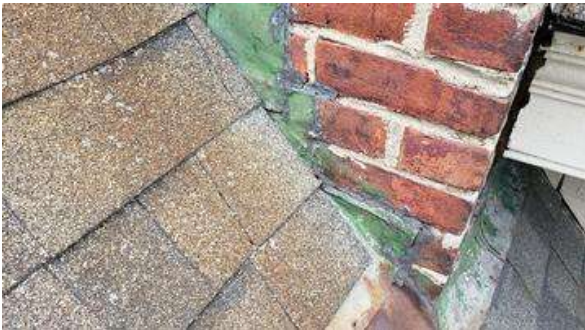
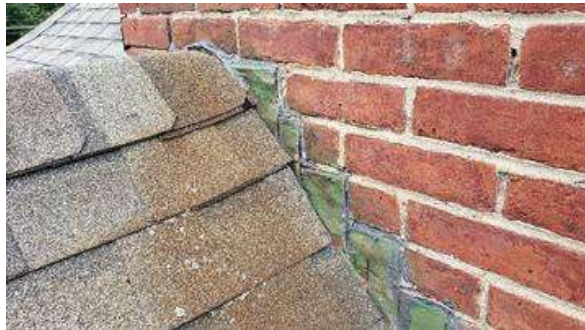
08/30/2020 Chimney flashing deteriorating. Flashing is very important to stopping moisture penetration which leads to wood rot and insect infestation. Recommend qualified contractor repair as necessary.

Chimney flashing deteriorating. Flashing is very important to stopping moisture penetration which leads to wood rot and insect infestation. Recommend qualified contractor repair as necessary.

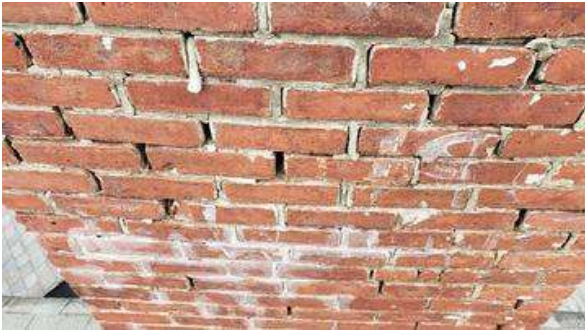
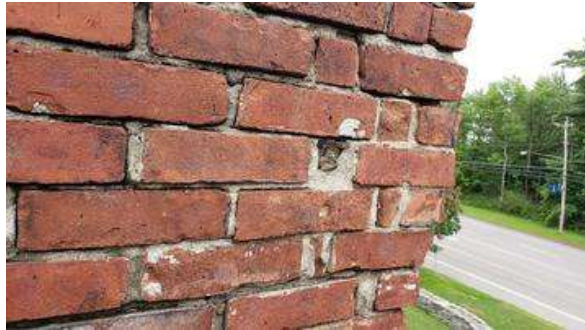
08/30/2020 Chimney brick needs re-pointing. Mortar is deteriorated and this will allow for water penetration damage and reduce integrity of the chimney. Recommend qualified contractor repair as necessary.

Chimney brick needs re-pointing. Mortar is deteriorated and this will allow for water penetration damage and reduce integrity of the chimney. Recommend qualified contractor repair as necessary.

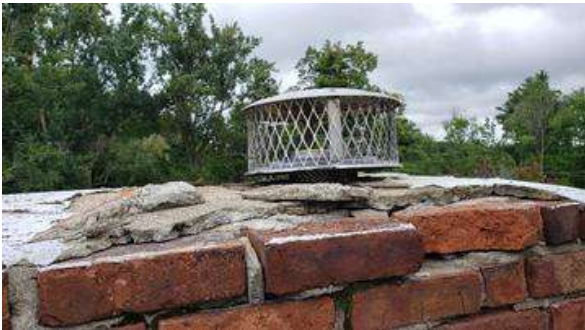
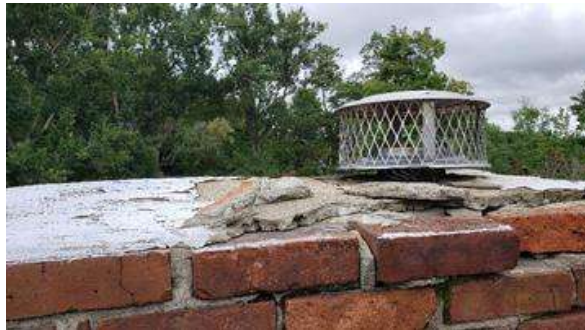
08/31/2020 Chimney crown is cracked. This allows water to infiltrate the brick and mortar, causing further damage to chimney. Recommend qualified contractor to fix and repair as necessary.

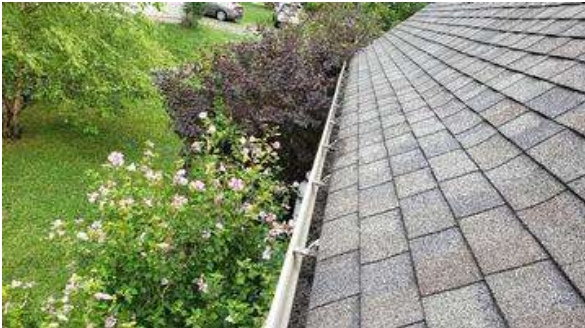
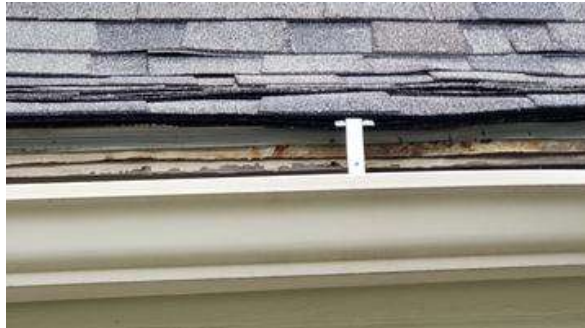
08/31/2020 Gutter too close/low to roof and roof pitch too great allowing water to flow over gutter and onto ground. This is causing the siding at the bottom of the wall to get wet and rot. Recommend qualified contractor repair as necessary.

Gutter too close/low to roof and roof pitch too great allowing water to flow over gutter and onto ground. This is causing the siding at the bottom of the wall to get wet and rot. Recommend qualified contractor repair as necessary.

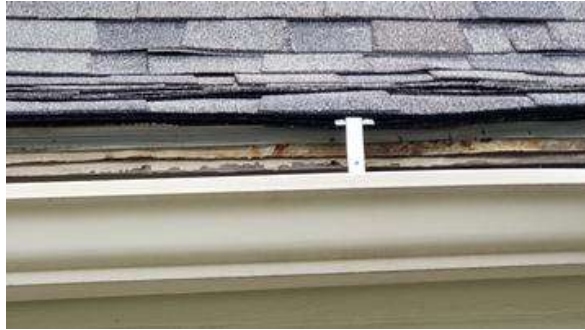
09/01/2020 Rotting wood on fascia boards due to gutter system that was integrated into roof that allowed water to infiltrate under shingle. Recommend qualified contractor repair as necessary.

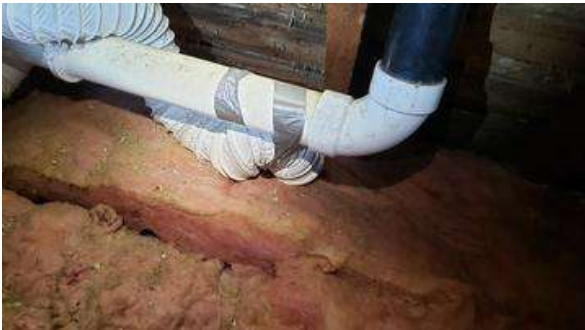
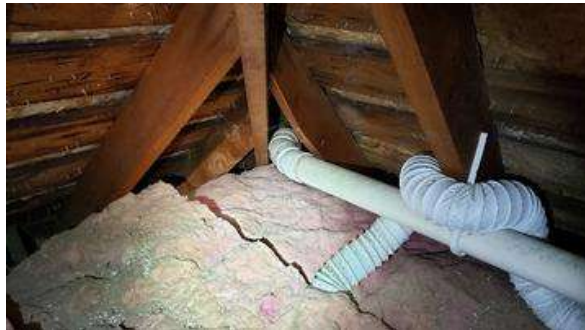
09/01/2020 Exhaust fan terminates in attic. Recommend installing a duct with minimum R8 insulation and vent cap on roof. Recommend qualified contractor repair as necessary.

Exhaust fan terminates in attic. Recommend installing a duct with minimum R8 insulation and vent cap on roof. Recommend qualified contractor repair as necessary.

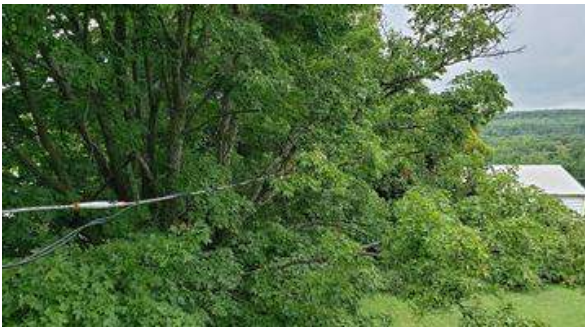
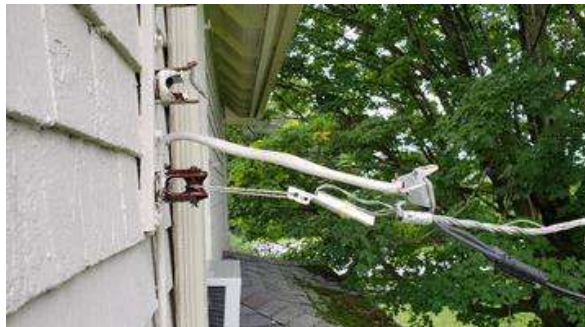
Service wires from pole are threatened by tree overhang and should have Electric Company inspect and provide remedy. Also service cable is being strained and needs to be reattached after tree is trimmed back.

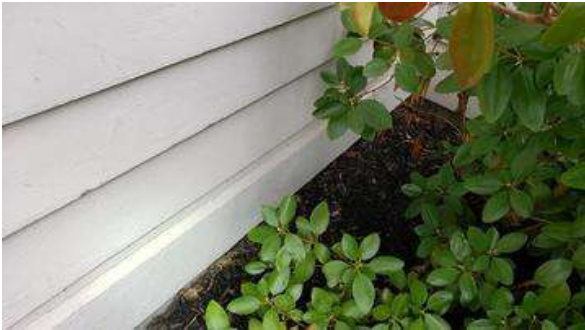
09/01/2020 Soil is in contact with or less than 6" from siding and/or trim. Recommend grading soil so there's at least 6" of space between the siding and trim and the soil below.

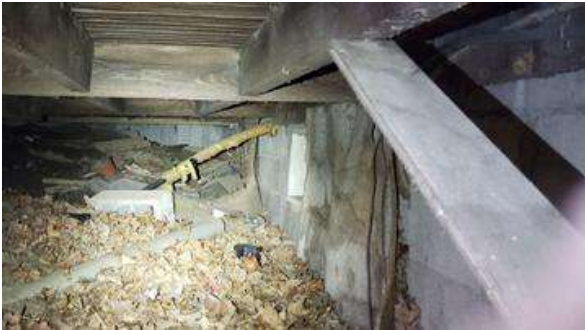
09/01/2020 Deck not properly attached at the joist to beam connection. This is a safety hazard if load is too great. Recommend qualified contractor repair as necessary.

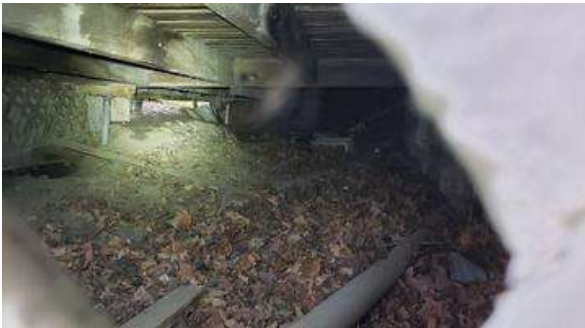
09/01/2020 Deck not properly attached at the post to beam connection. This is a safety hazard if load is too great. Recommend qualified contractor repair as necessary.

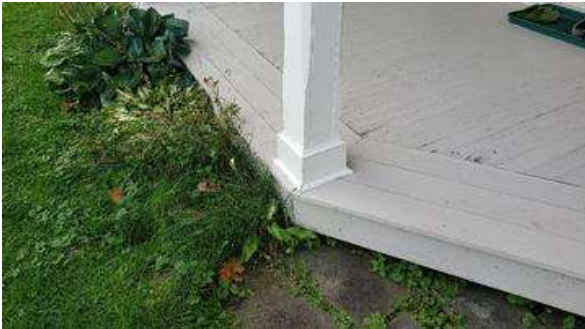
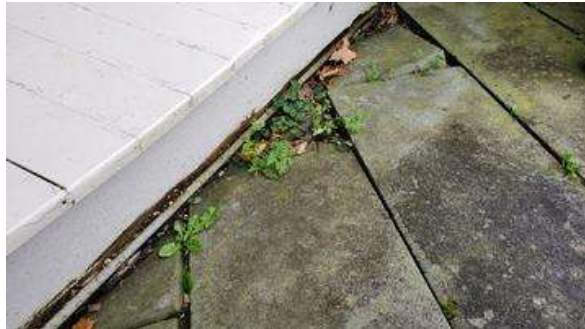
09/01/2020 Deck in contact with soil/pavers. Wood being in contact with soil will absorb the moisture and rot over time. Some deterioration is evident. Recommend qualified contractor repair as necessary.

Deck rim joist rotted

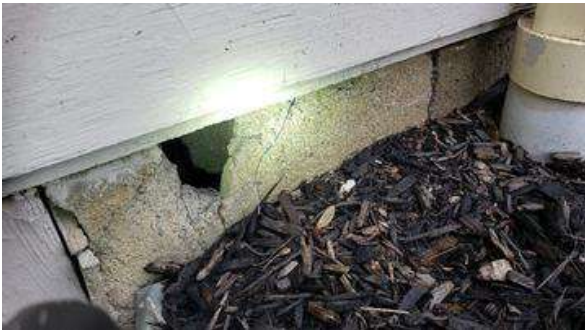
09/01/2020 Noted cracks/hole in foundation. This can allow water infiltration which will lead to further damage. Recommend qualified contractor to fix and repair as necessary.

Noted cracks/hole in foundation. This can allow water infiltration which will lead to further damage. Recommend qualified contractor to fix and repair as necessary.

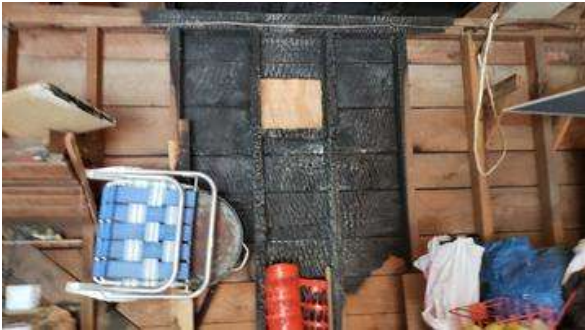
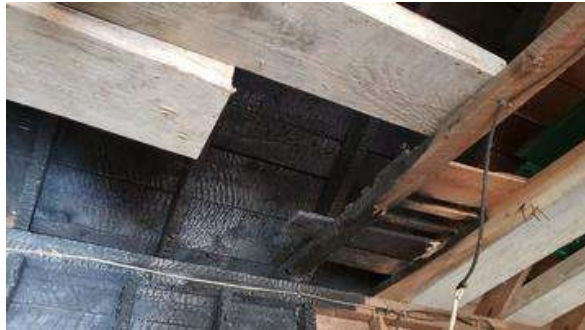
09/01/2020 Fire damage in attic leaving structure integrity to be questioned. Recommend qualified contractor repair as necessary.

Fire damage in attic leaving structure integrity to be questioned. Recommend qualified contractor repair as necessary.

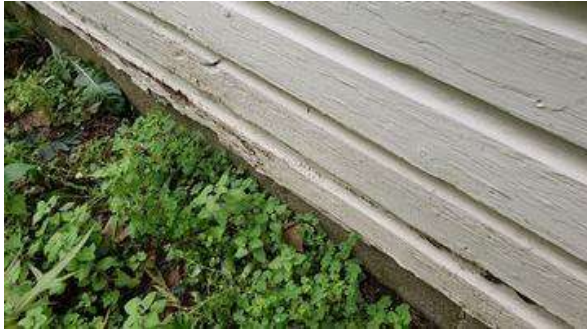
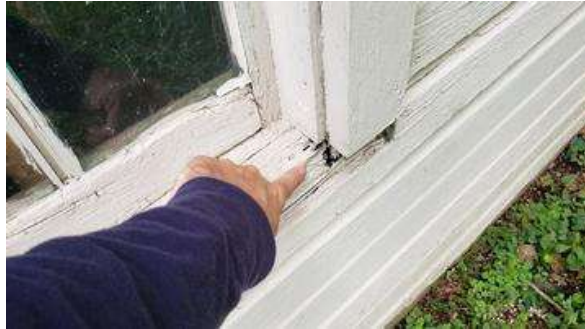
09/01/2020 Garage siding/trim water damage and rotting due to being in contact with soil. Recommend installing gutter and repairing any rotten areas of structure. Foundation must be kept dry.

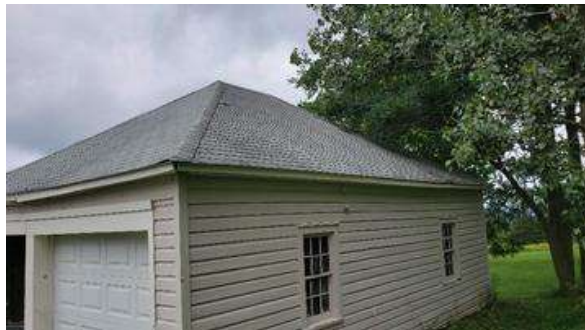
09/01/2020 Trees are overhanging roof and are within 10 feet of roof vertically. Recommend pruning trees so they're at least 10 feet above roof, or don't overhang the roof

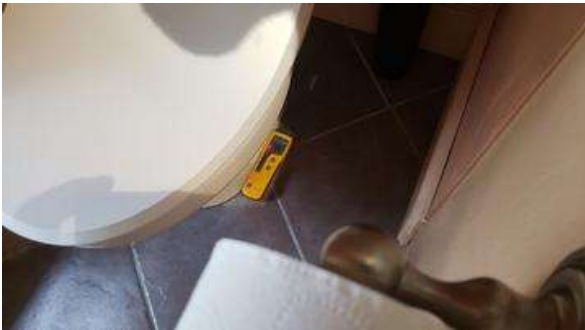
09/01/2020 Moisture meter has detected water penetration in framing and sub flooring around the base of the toilets that will damage wood. Recommend qualified contractor repair as necessary.

Moisture meter has detected water penetration in framing and sub flooring around the base of the toilets that will damage wood. Recommend qualified contractor repair as necessary.

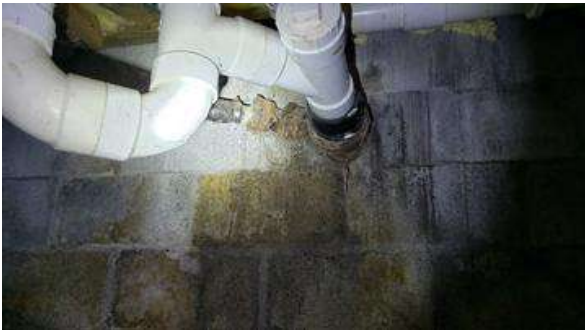
Some of the waste pipes in the plumbing was cast iron and rusting. These are older and will plug up due to interior corrosion and leak. Recommend qualified contractor repair as necessary.

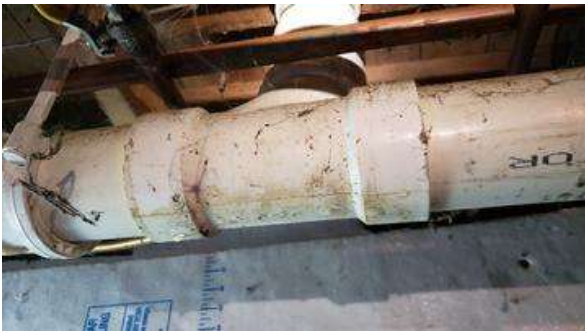
One or more active leaks were found in drain and/or waste pipes or fittings. A qualified plumber should evaluate and repair as necessary.

Half bath toilet leak

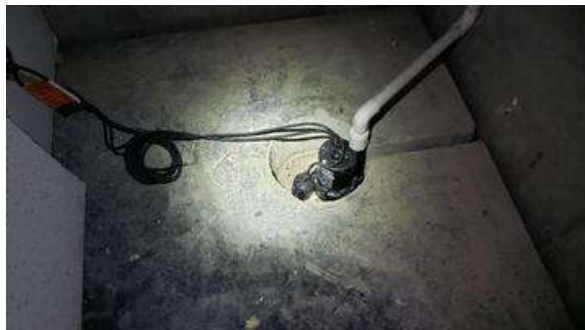
09/01/2020 Sump opening not covered allowing for a trip hazard for all and a drowning hazard for small children. Recommend proper covering and blocking access from children.

Sump opening not covered allowing for a trip hazard for all and a drowning hazard for small children. Recommend proper covering and blocking access from children.

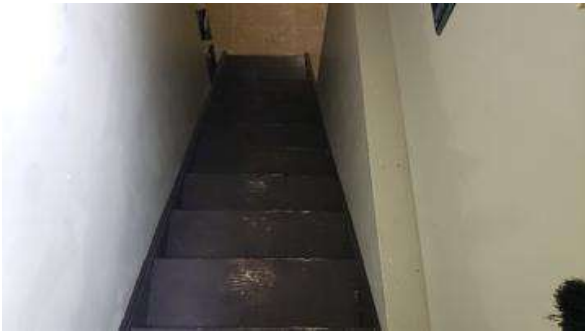
09/01/2020 No handrail noted on basement steps. This is a safety hazard and may lead to serious injury. Recommend repair by a qualified contractor.

No handrail noted on basement steps. This is a safety hazard and may lead to serious injury. Recommend repair by a qualified contractor.

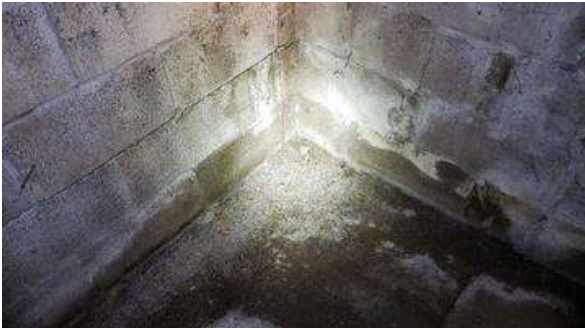
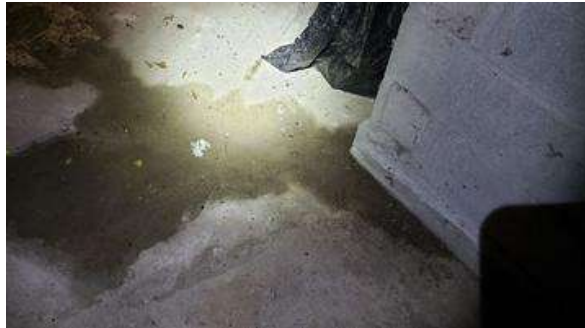
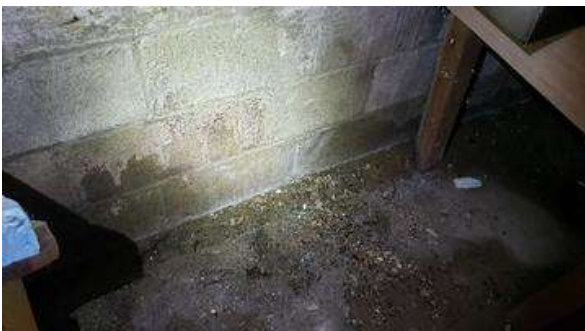
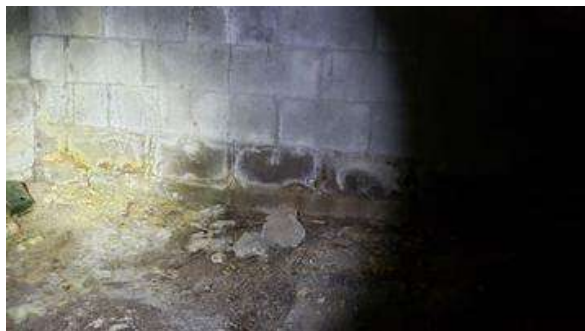
Signs of moisture on basement walls. Recommend gutters be installed/upgraded on house and grade/drainage be improved to keep water away from foundation. Contact a qualified contractor to determine proper method of sealing the basement from further deterioration.

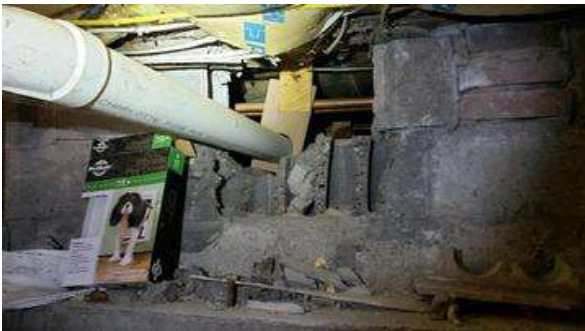
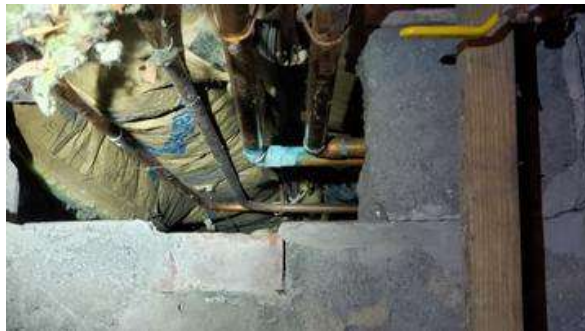
Foundation wall has access holes/notches cut to allow for routing of pipes. Any holes/notches cut into wall will compromise the integrity of wall. Recommend qualified contractor repair as necessary.

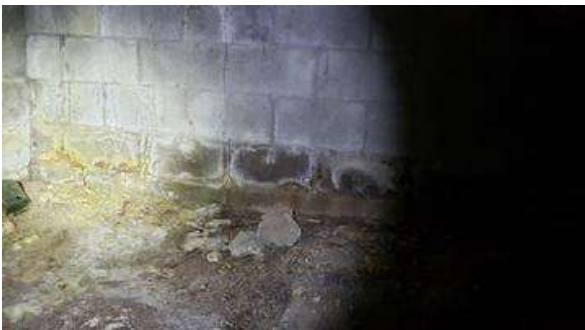
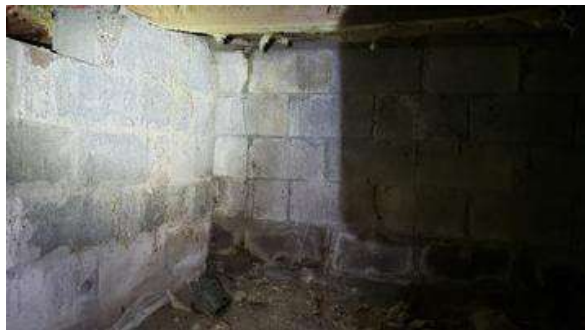
Basement has visible cracks of foundation block/stone/brick due to what might be hydro-static pressure from negative slope of grade. Recommend a qualified contractor be contacted to evaluate foundation wall.

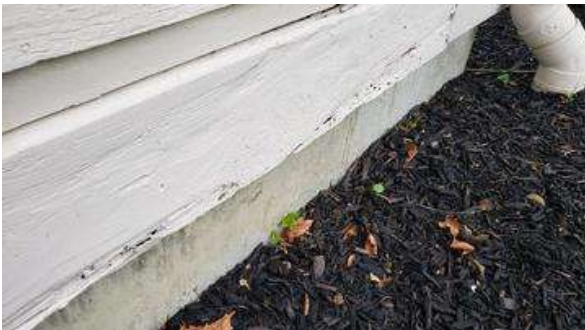
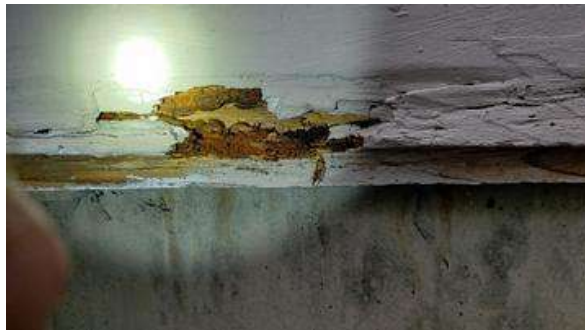
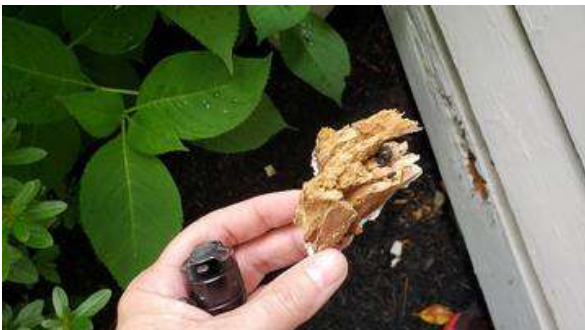
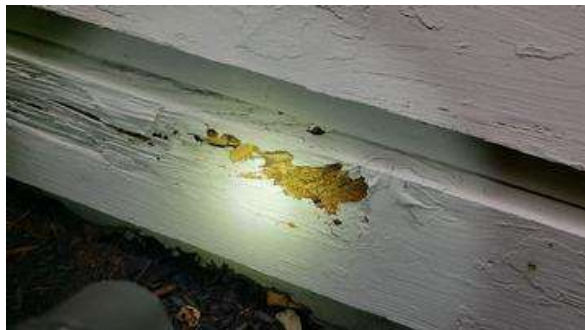
Wood damage noted. Recommend qualified exterminator evaluate for active or future infestation. Recommend qualified contractor evaluate and repair damage noted.
